Appendix 9-A

RESULTS OF A FIELD SURVEY OF BMPs

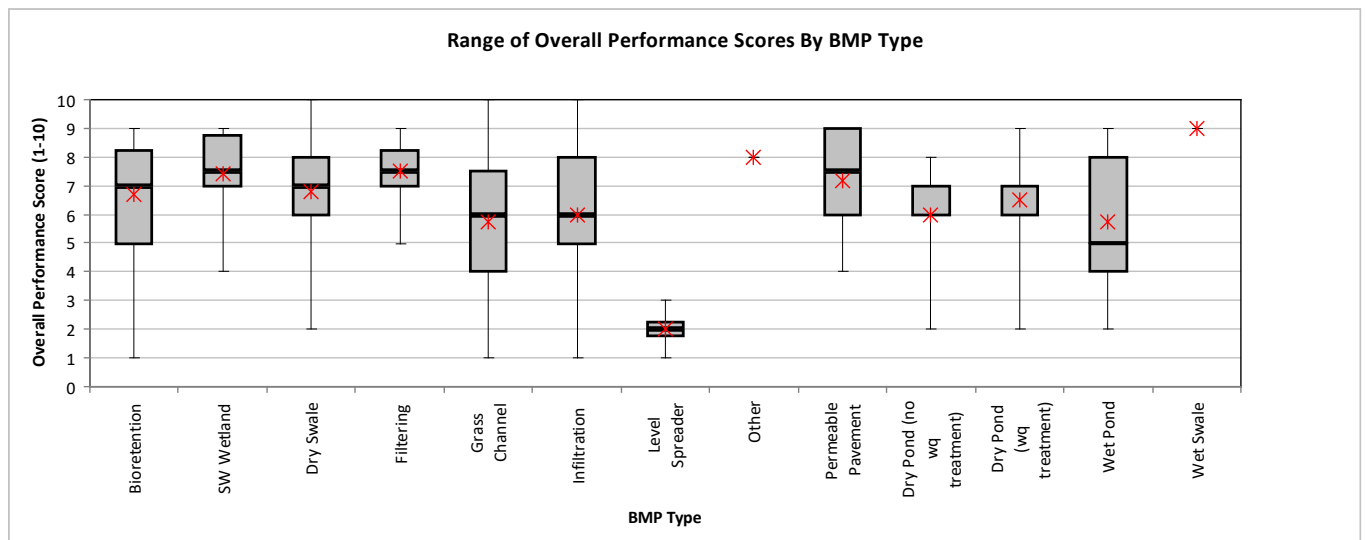
Figure 9-A.1. Box and Whisker Plot for the Range of Overall Performance Scores by BMP Type
(Source: CWP, 2009)

As can be seen in **Figure 9-A.1**, most types of BMPs had mean scores in a range indicating the BMP design is adequate, but the plots for several BMPs indicate performance problems. Wet ponds, dry ponds, infiltration devices, and grass channels had somewhat lower mean scores, and level spreaders generally had significant performance issues.

As might be expected, the ranges of scores are quite large, indicating that each type of practice has some representatives that are failing and others that are performing very well. Some of the practices with the widest ranges of performance scores include bioretention, grass channels, infiltration, permeable pavement, and wet ponds. This may indicate that design, installation, and maintenance guidelines for these practices are not yet well articulated or applied consistently. As one result of this survey, the DEQ is providing much improved BMP specifications on the Virginia Stormwater BMP Clearinghouse web site (<http://www.vwrrc.vt.edu/swc/>). The following is a summary of some specific BMP performance issues identified by the field survey (examples in **Figure 9-A.2** below):

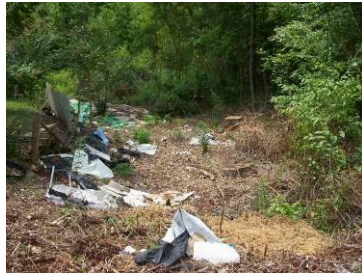
Accumulation of trash and debris

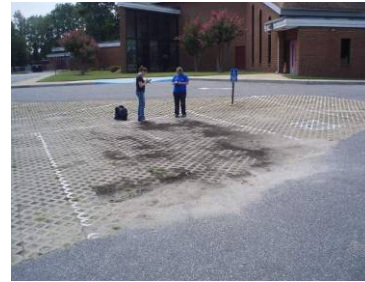
Clogged pavers and non-infiltrating infiltration bed

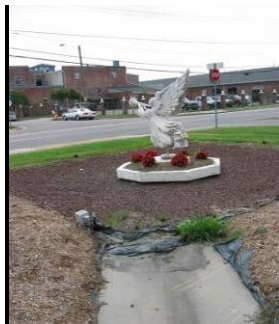
Property owners filled in rain garden and replaced it with a sculpture

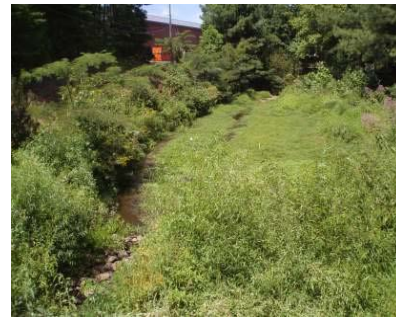
Sediment forebay filled in and became vegetated

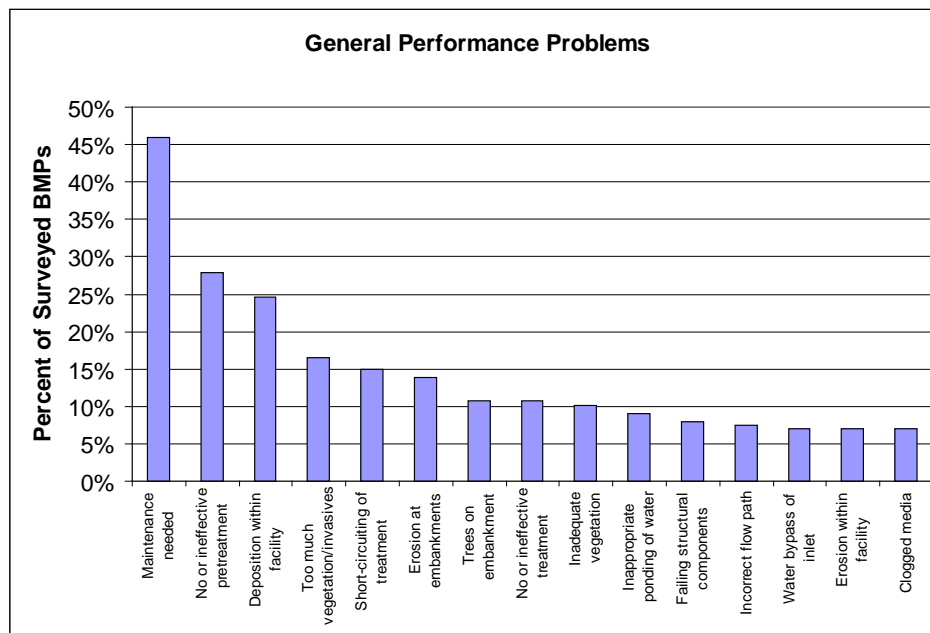
Figure 9-A.3. Incidence of the most common performance problems (Source: CWP, 2009)

Figure 9-A.3 shows the incidence of the most common performance problems.
