**Downstream DefenderÒ Report Sections**

**Final Report  
for Onondaga Lake Nonpoint  
Source Environmental Benefit Project**

**November 2002**

*Submitted by  
Moffa and Associates  
A Unit of Brown and Caldwell  
East Syracuse, NY*

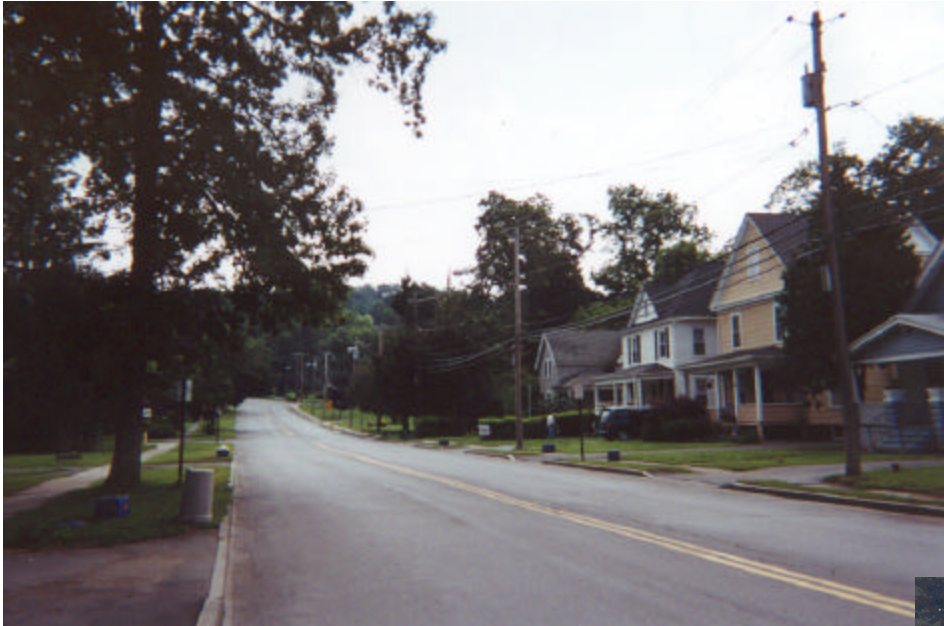
Stormwater Vortex Unit Catchment Area

A stormwater vortex unit was installed at 134 East Seneca Turnpike for the purpose of removing suspended solids and associated nutrients from the stormwater before discharge to Onondaga Creek. The catchment area serviced by this unit primarily encompasses a 1,000-foot length of East Seneca Turnpike and is approximately 1.2 acres in size. The unit is a 4-foot diameter Hydro International Downstream Defender® with a design flow of 0.75 cfs and a maximum capacity of 3.0 cfs. Figure 30 shows a portion of the catchment area and Figure 31 shows the unit during installation.

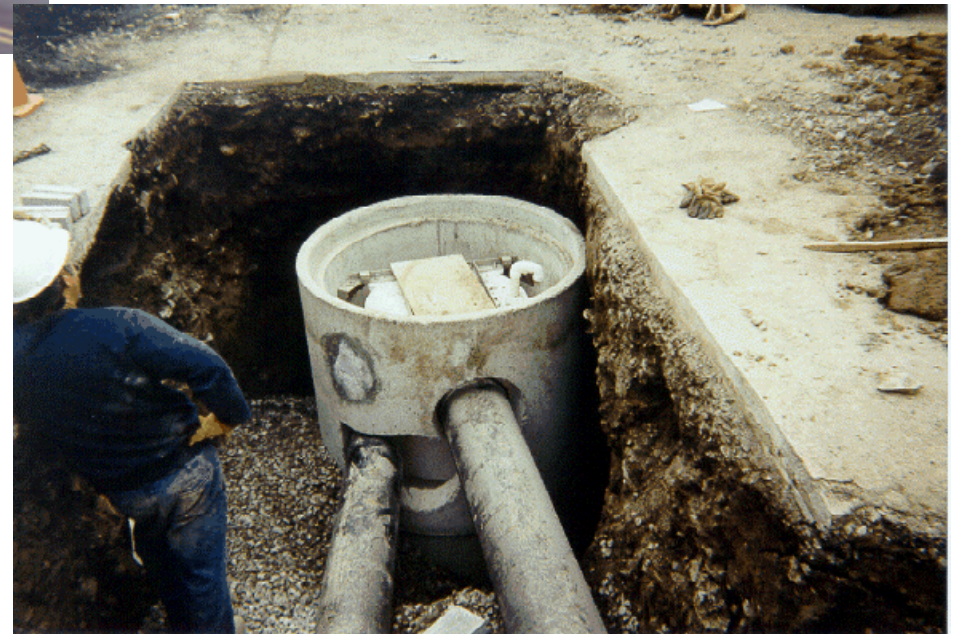
Stormwater Vortex Unit Installation

Installation of the Downstream Defender® was fairly simple, considering that the location of the stormwater sewer was on the edge of a busy city street. As a result of the location of the sewer, the unit was installed off-line instead of directly in-line with the sewer. This required removing a three-foot section of the sewer and replacing it with a diversion manhole. The diversion manhole was constructed with a weir wall that diverts flow out of the stormwater sewer and into the unit. Once the flow is processed through the unit it is piped back into the diversion manhole on the other side of the weir wall where it flows back into the stormwater sewer.

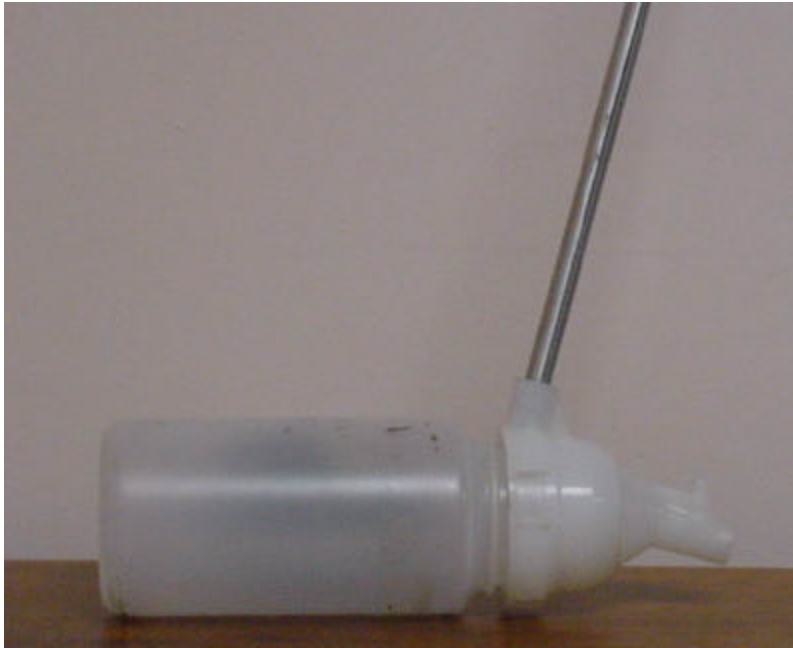
**US DH-81A Sampler**

sampling is the issue of solids maceration; submersible pumps can break large solids apart and bias the analytical results. After discussions with the stormwater vortex manufacturer, it was decided not to use the pumps, but instead use a US DH-81A sampler, which was specifically designed for sampling sediment in flowing water. A photo of the US DH-81A sampler is illustrated in Figure 39.

The US DH-81A sampler was used during the first five events, but concerns developed regarding the representativeness of the samples. The US DH-81A sampler is essentially a sample bottle with a specially designed nozzle that allows the bottle to be oriented in a horizontal position without losing the sample. Both the bottom of the sample bottle and the nozzle create increased flow pressure, which results in water flowing around the sample bottle and not into the bottle. As a result of the concern that the US DH-81A sampler was not taking representative samples of the sediment load, a Van Dorn sampler was used to sample during the last event. The Van Dorn sampler is illustrated in Figure 40.

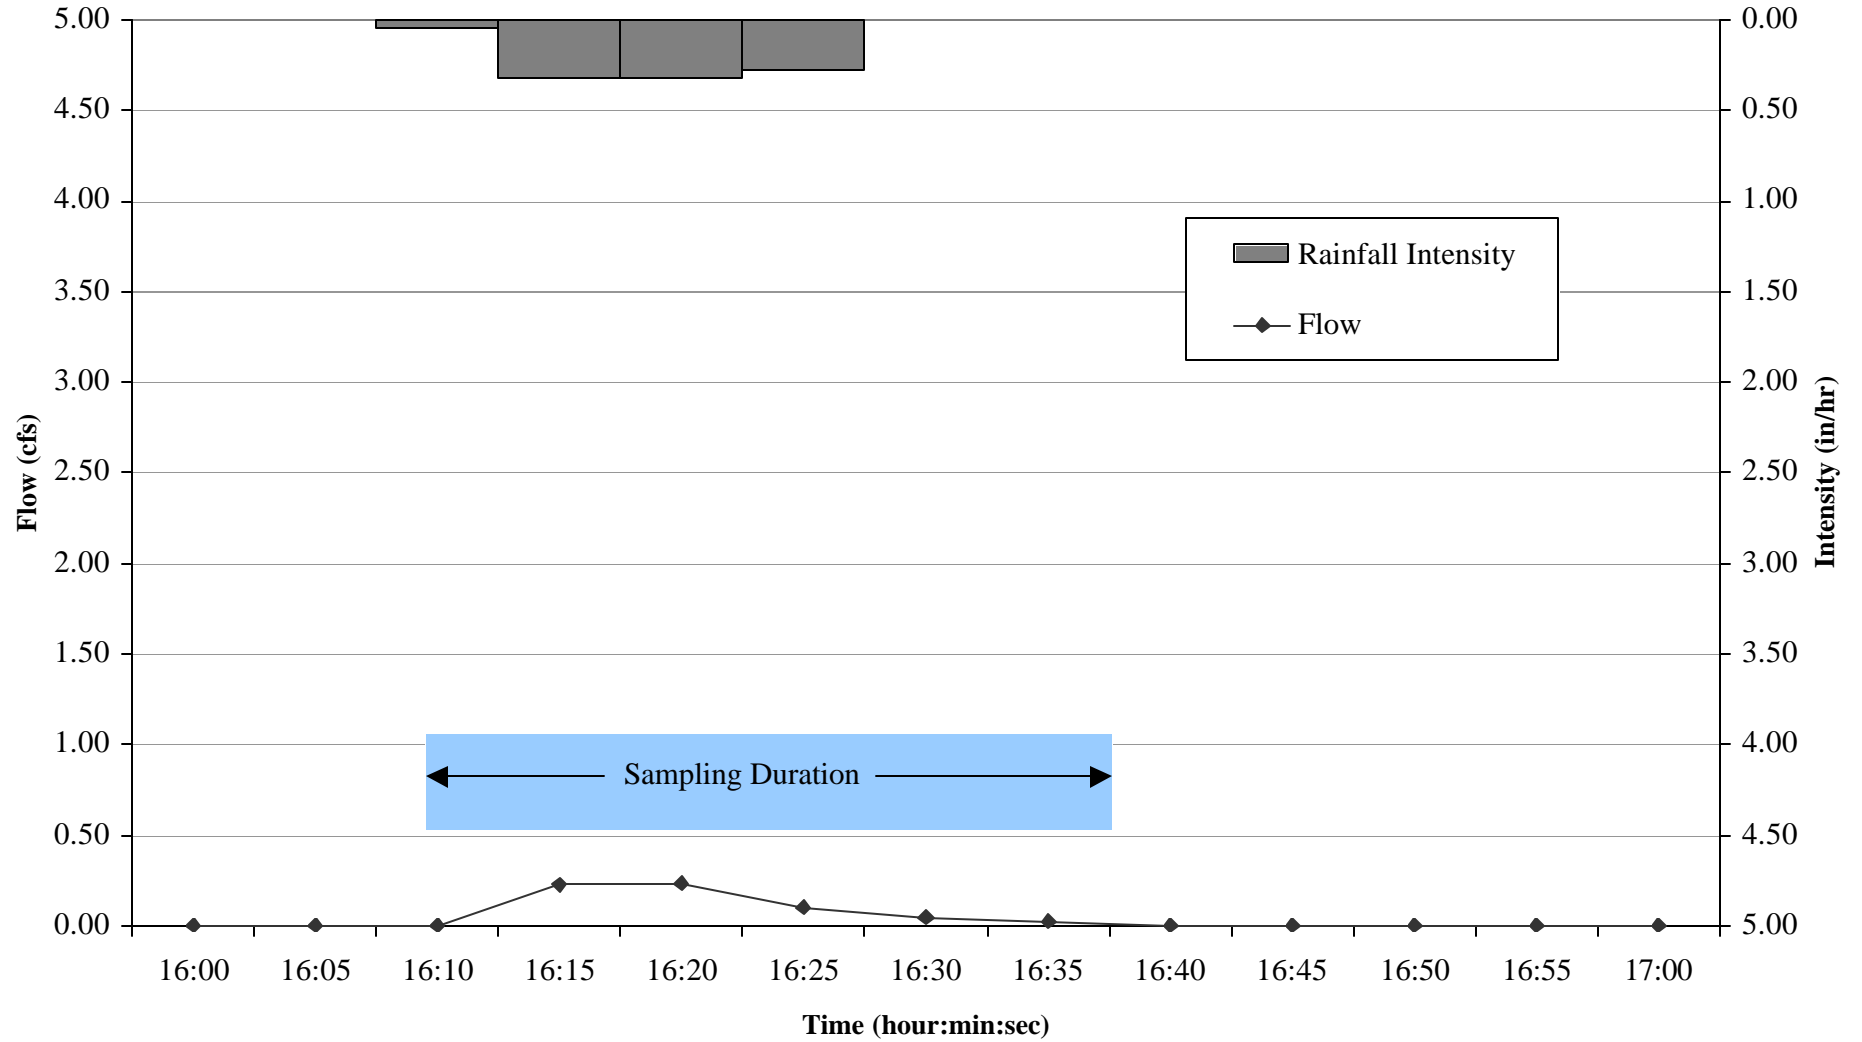
**1 Hour Storm Hydrograph**  
**Downstream Defender - Syracuse, NY**  
**July 24, 2001**

Figures 84 through 89 show the hyetographs and hydrographs from each of the six sampled

storm events. Peak flows by event ranged from 0.3 cfs to 1.9 cfs. The peak flow of 1.9 cfs was generated from approximately 0.35 inches of rain falling in a 15 minute time period. This equates to a rain intensity of 1.4 inches per hours, which is equivalent to approximately one-half the intensity of the 1-year return frequency storm for the City of Syracuse. As a frame of reference the 4-ft diameter Downstream Defender® design flow rate is 0.75 cfs and the maximum capacity is 3.0 cfs. The design flow of 0.75 cfs was exceeded during three of the six sampled storm events. As discussed in Section 4.3.1, a 4-ft diameter unit was installed so that the design flow would be exceeded approximately once or twice a month for the purposes of sampling the unit while it operated at or near the design conditions.

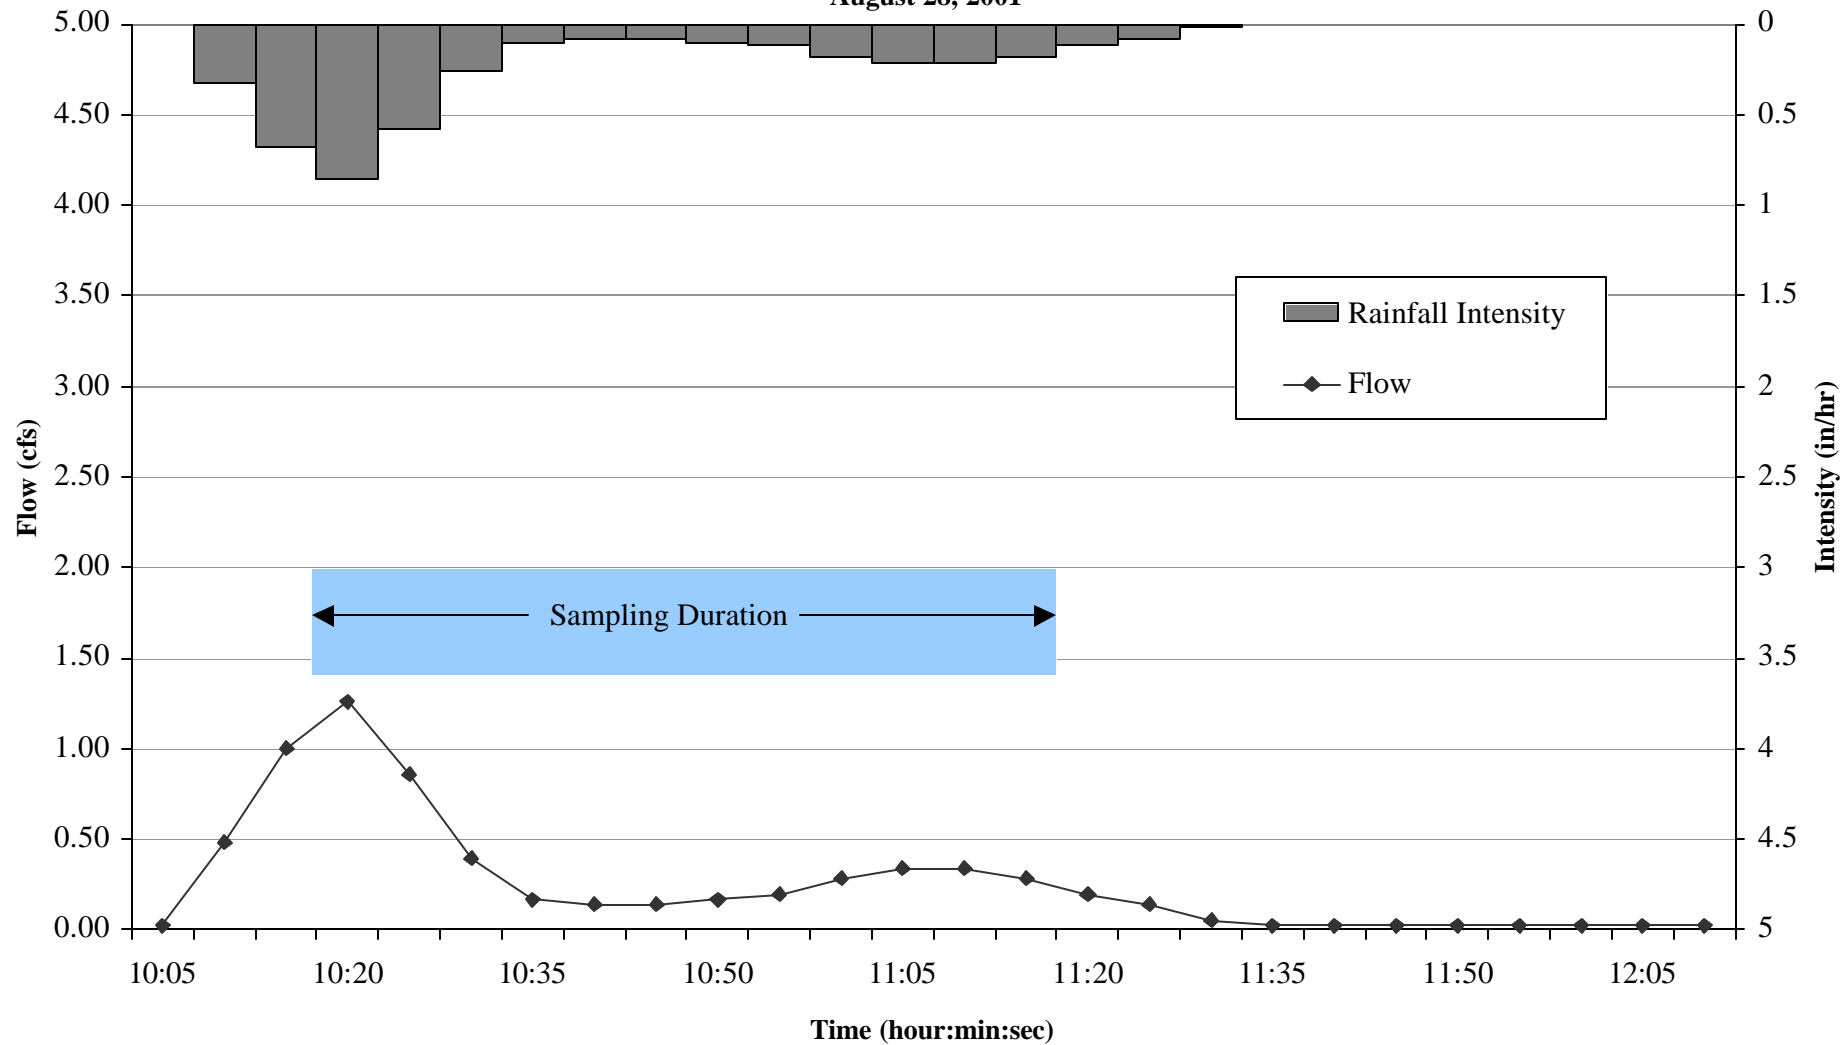
**2 Hour Storm Hydrograph**  
**Downstream Defender - Syracuse, NY**  
**August 28, 2001**

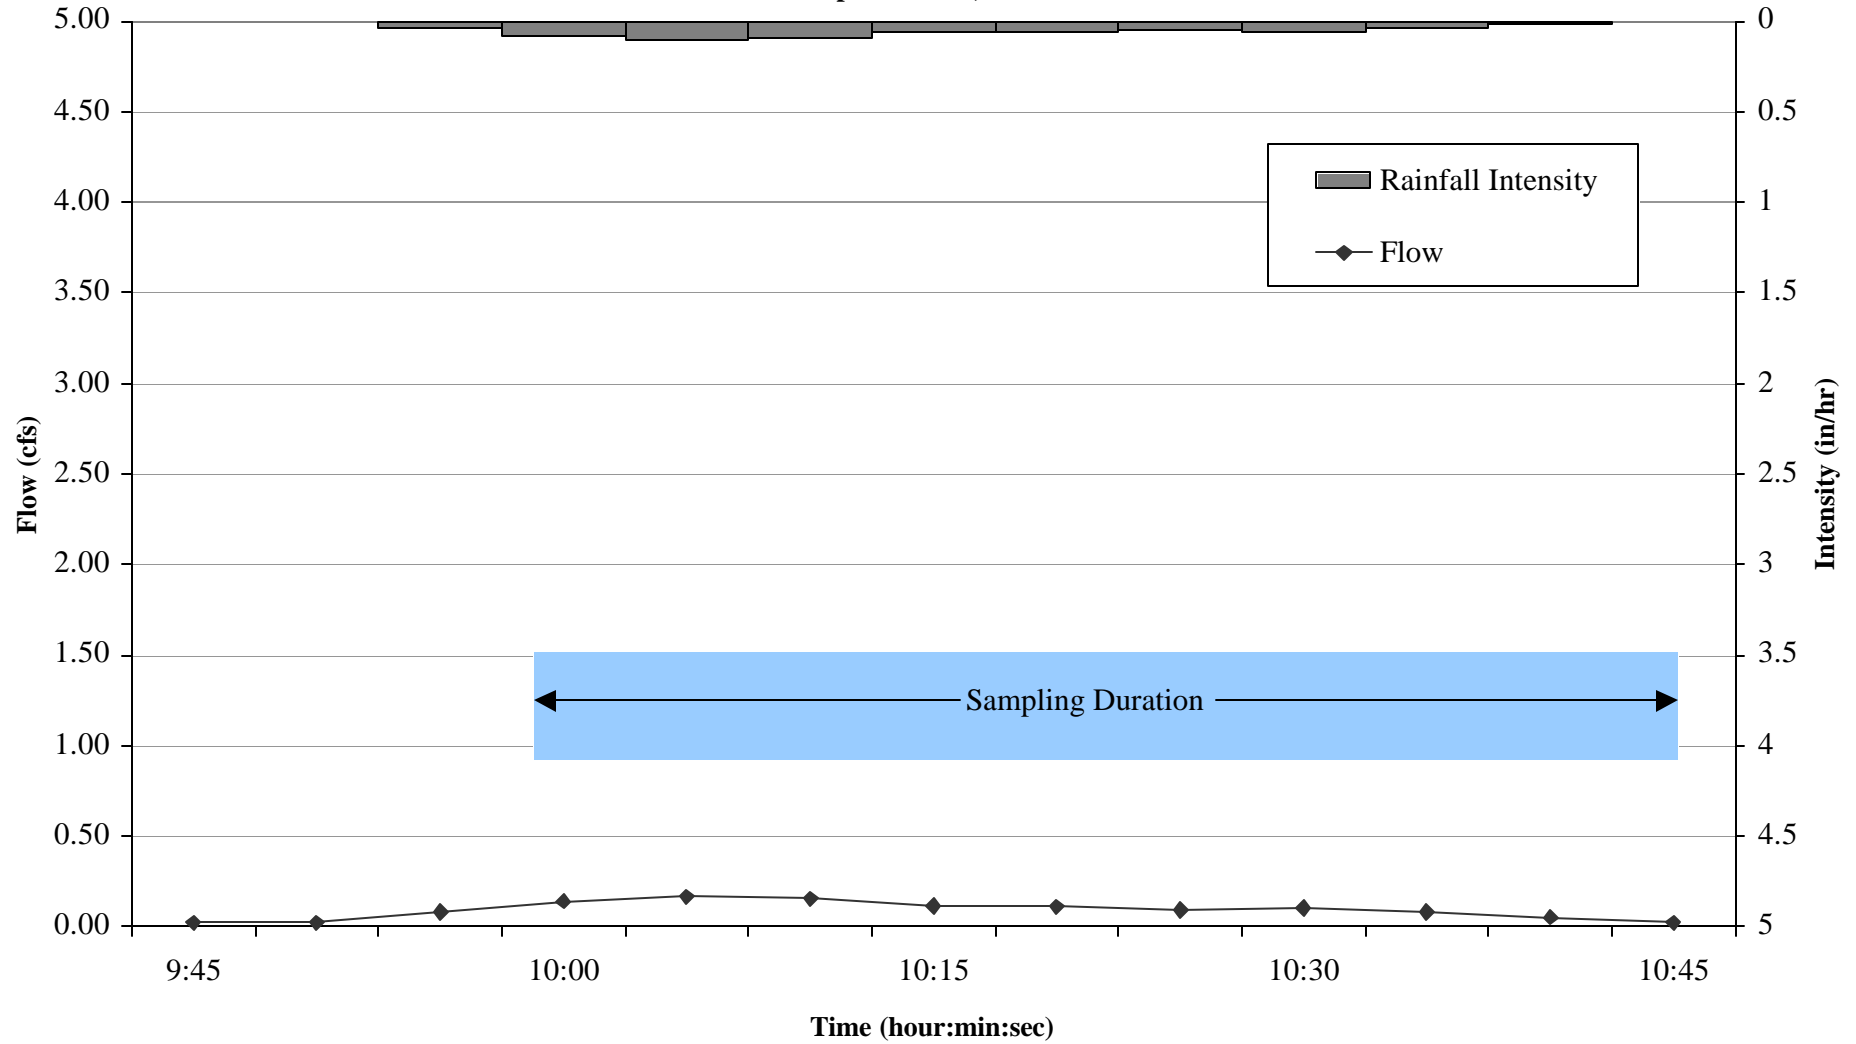
**1 Hour Storm Hydrograph**  
**Downstream Defender - Syracuse, NY**  
**September 13, 2001**

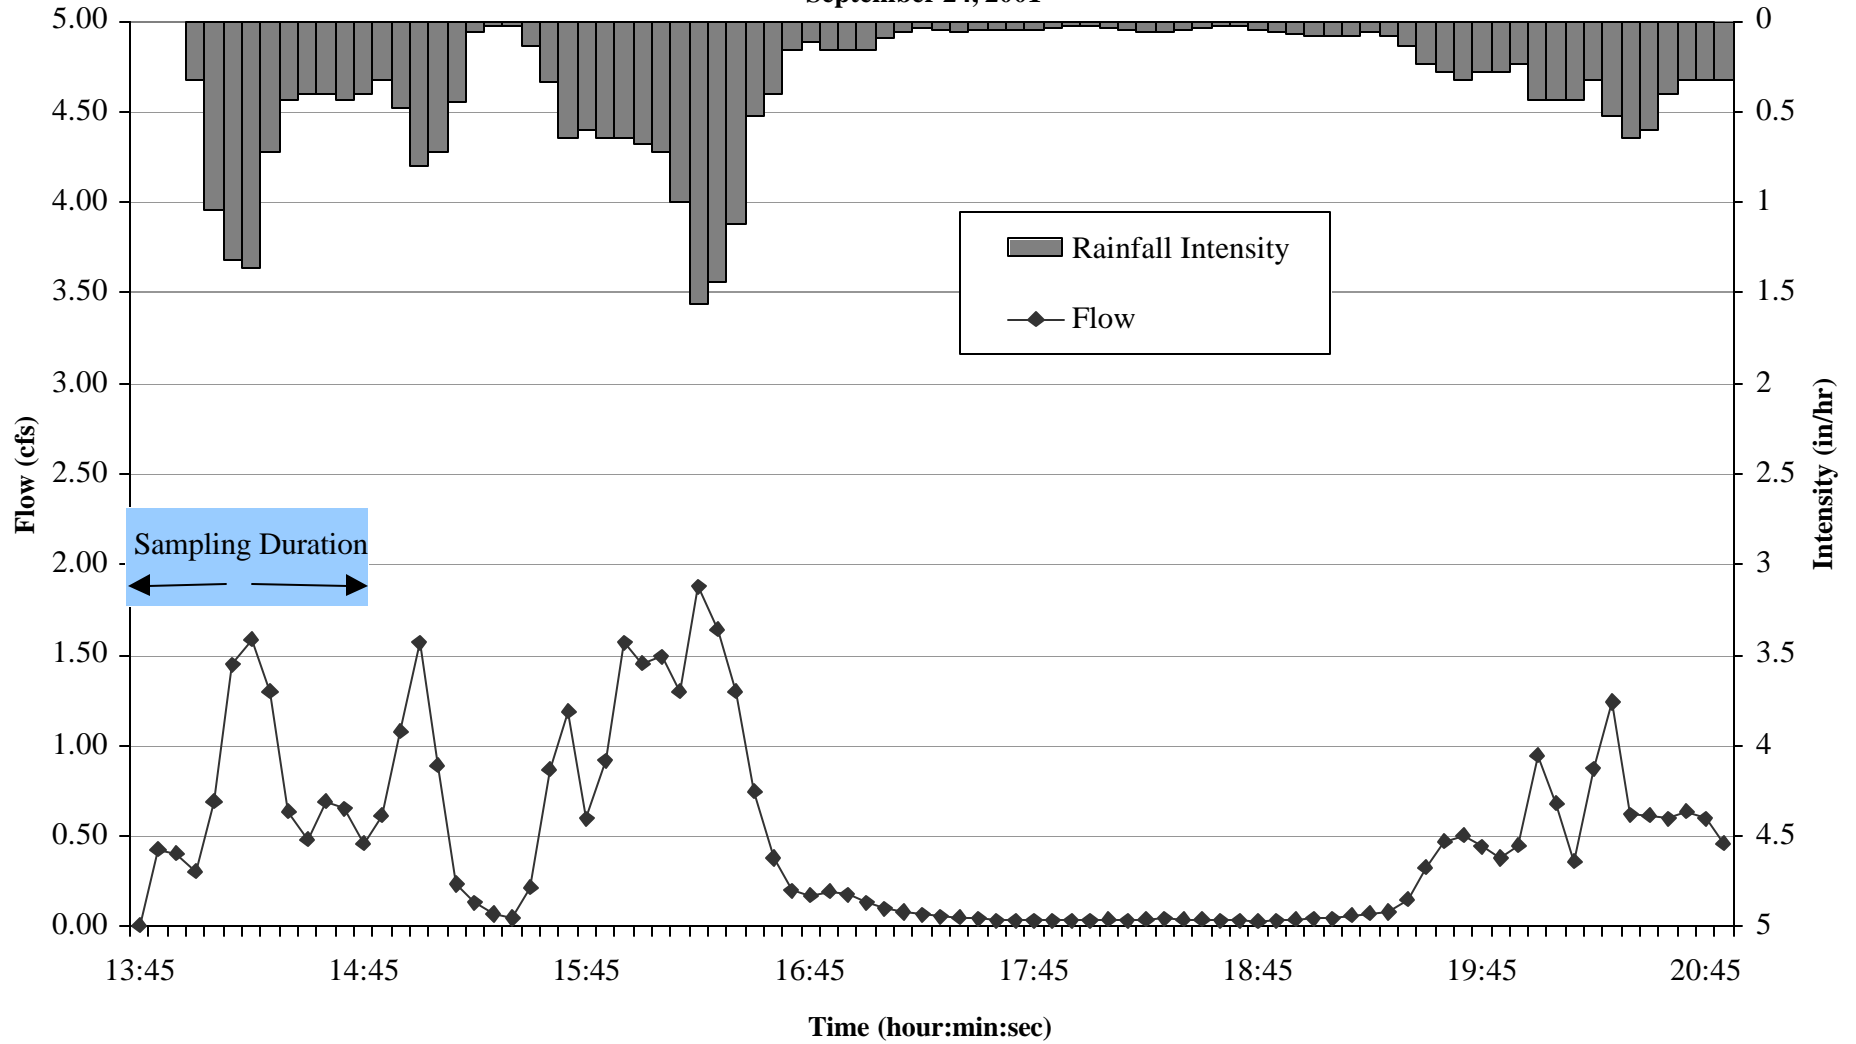
**7 Hour Storm Hydrograph**  
**Downstream Defender - Syracuse, NY**  
**September 24, 2001**

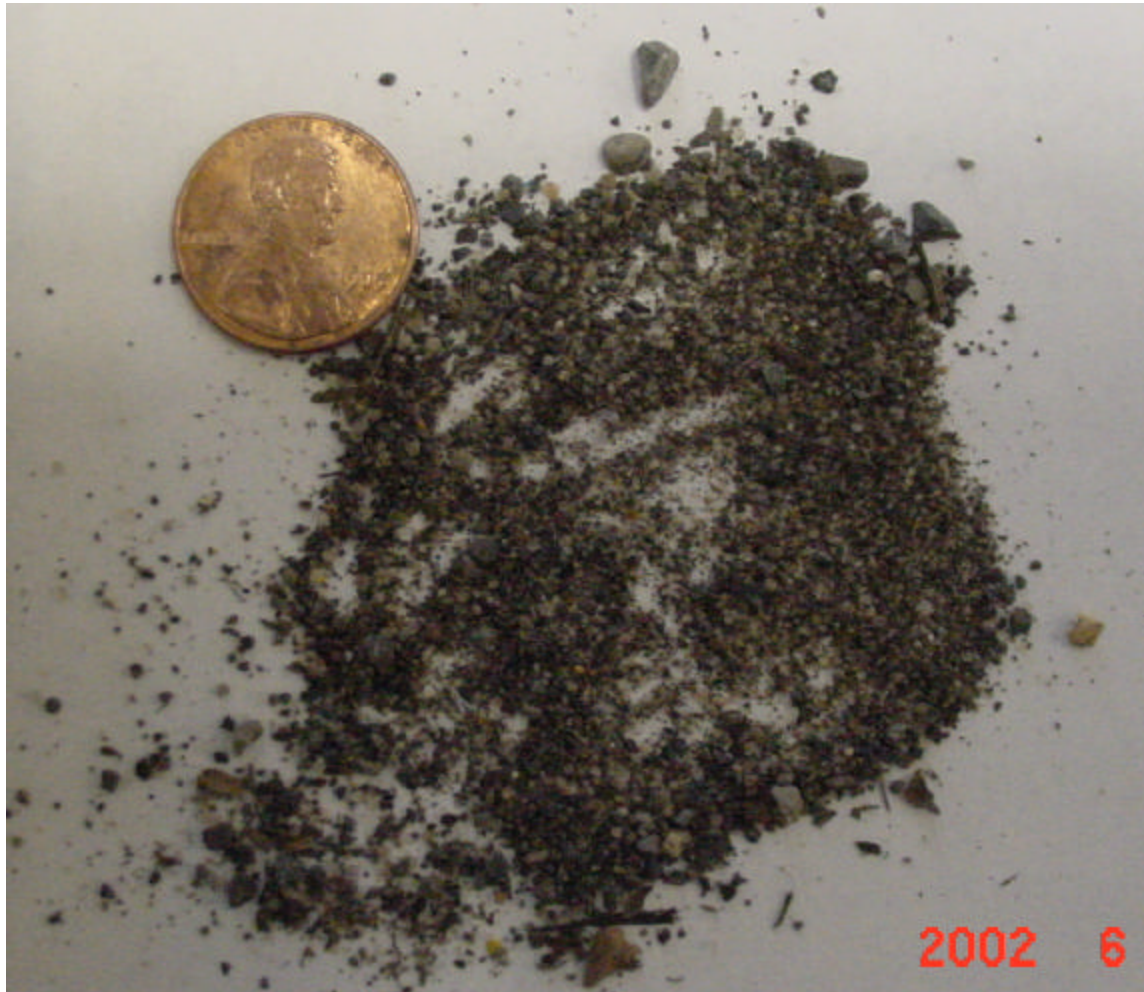
**Influent Stormwater Vortex Unit Solids Sample: Coarse to Medium Grit**
